Manhole Inspection Summary

Manhole # S37Y1_019MH

Insp Date: **4/9/08 12:06 PM**

Location Address: **3802 4th St.**

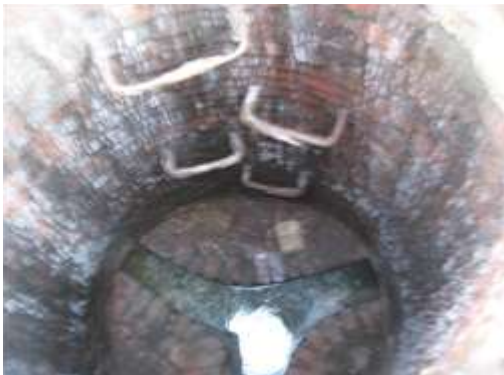
Steps Count: **4** Missing: **0** ☒ **Corroded**

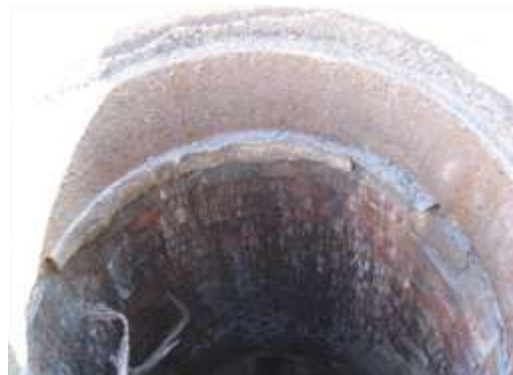
Defect 1

Condition: ☐ Sound ☐ Cracked ☐ Root Intrusion ☐ Loose Brick ☒ **Deteriorated**

Infiltration: ☐ None ☒ **Joint** ☐ Cracks ☐ Mortar ☐ Roots ☐ Wall

Joint

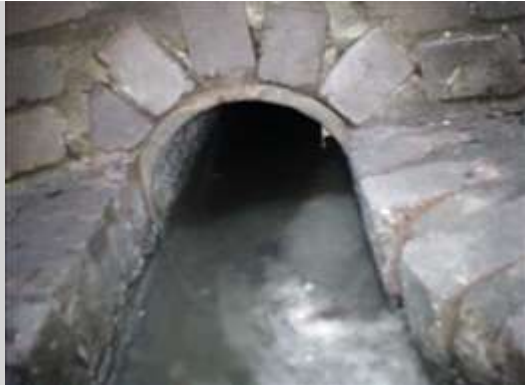
12 O'Clock Outflow

8 in. Circular Gravity Sewer
Pipe Out @ 12 O'Clock

Pipe Height: **10.8** (in.) Rod and Bar (Angled)
Pipe Material: **Clay** ☐ Pipe Lined
Invert Depth: **12.30** (ft.) Flow Characteristics: **Fast**
Deposits: ☐ None ☒ **Mud** ☒ **Sludge** ☐ Debris ☐ Grease
Silt Depth: **1** (in.) Deposits Extent: **Light**
Infiltration: **None** Pipe Seal Cond: **Sound**

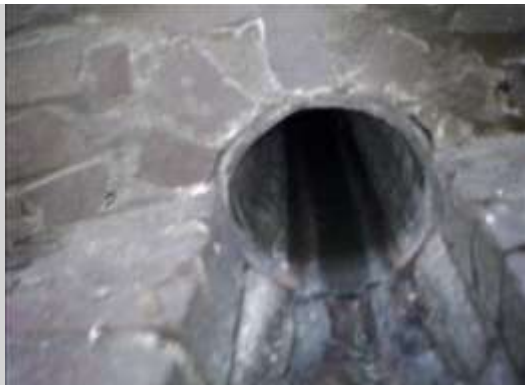
3 O'Clock Inflow

8 in. Circular Gravity Sewer
Pipe In @ 3 O'Clock

Pipe Height: **9.6** (in.) Rod and Bar (Angled)
Pipe Material: **Clay** ☐ Pipe Lined
Invert Depth: **11.88** (ft.) Flow Characteristics: **Fast**
Deposits: ☒ None ☐ **Mud** ☐ **Sludge** ☐ Debris ☐ Grease
Silt Depth: **1** (in.) Deposits Extent: **Light**
Infiltration: **None** Pipe Seal Cond: **Sound**

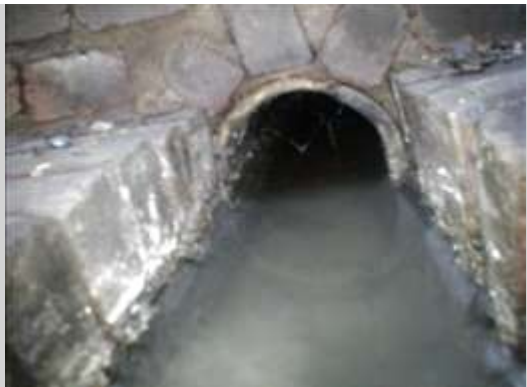
8 O'Clock Inflow

8 in. Circular Service Sewer
Pipe In @ 8 O'Clock

Pipe Height: **8.4** (in.) Rod and Bar (Angled)
Pipe Material: **Clay** ☐ Pipe Lined
Invert Depth: **12.12** (ft.) Flow Characteristics: **Fast**
Deposits: ☐ None ☒ **Mud** ☒ **Sludge** ☐ Debris ☐ Grease
Silt Depth: **1** (in.) Deposits Extent: **Light**
Infiltration: **None** Pipe Seal Cond: **Sound**
